Docket No. 217 – Development and Management Plan Inspection

Northeast Utilities Service Company Certificate of Environmental Compatibility and Public Need for the construction of a 345-kV electric transmission line and reconstruction of an existing 115-kV electric transmission line between Connecticut Light and Power Company's Plumtree Substation in Bethel, through the towns of Redding, Weston, and Wilton, and to the Norwalk Substation in Norwalk, Connecticut.

Date: February 2, 2006

Location: Norwalk Substation Expansion

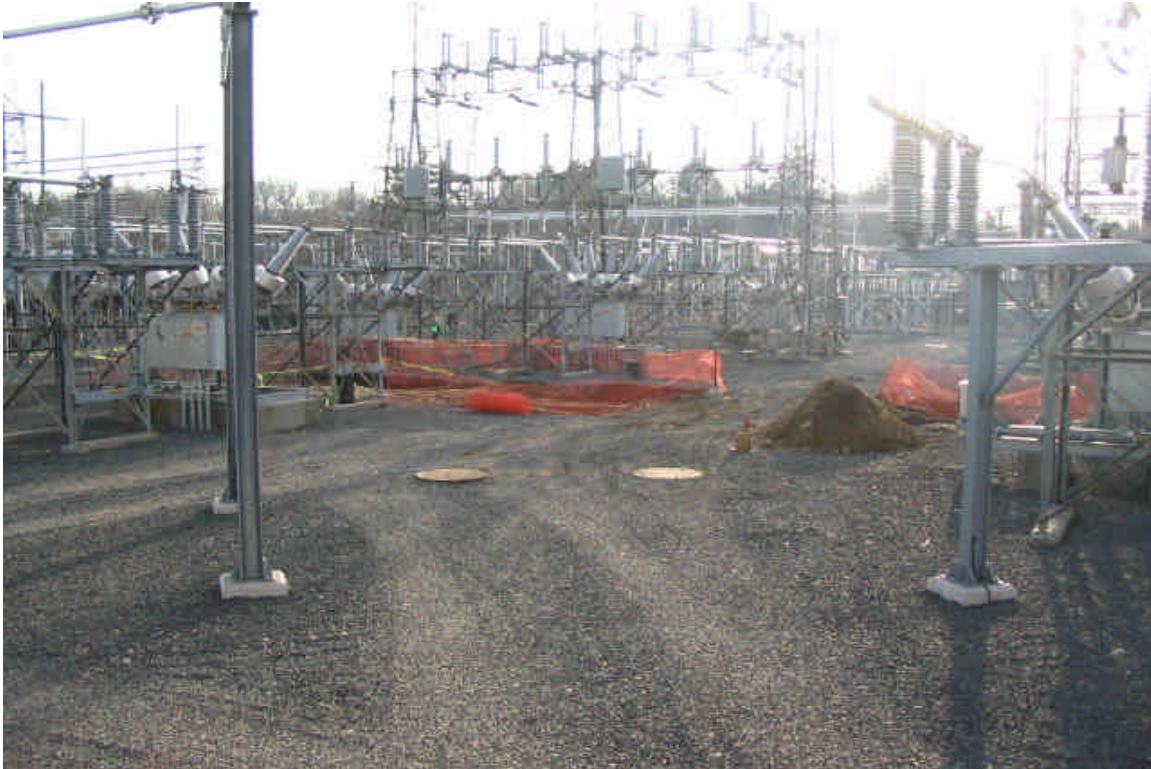
**Norwalk Substation: Work continues in the electrified yard. Small stockpiles remain contained.
2/2/06.**

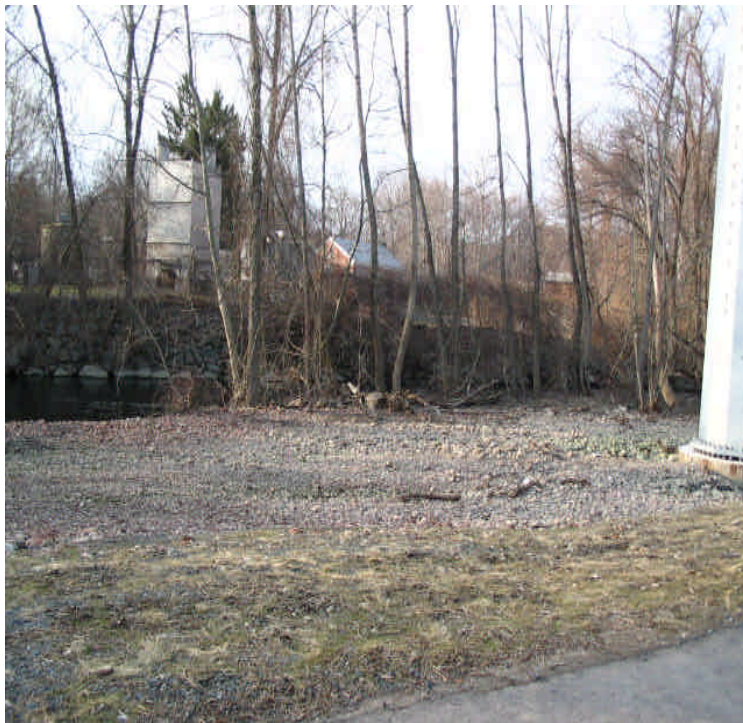
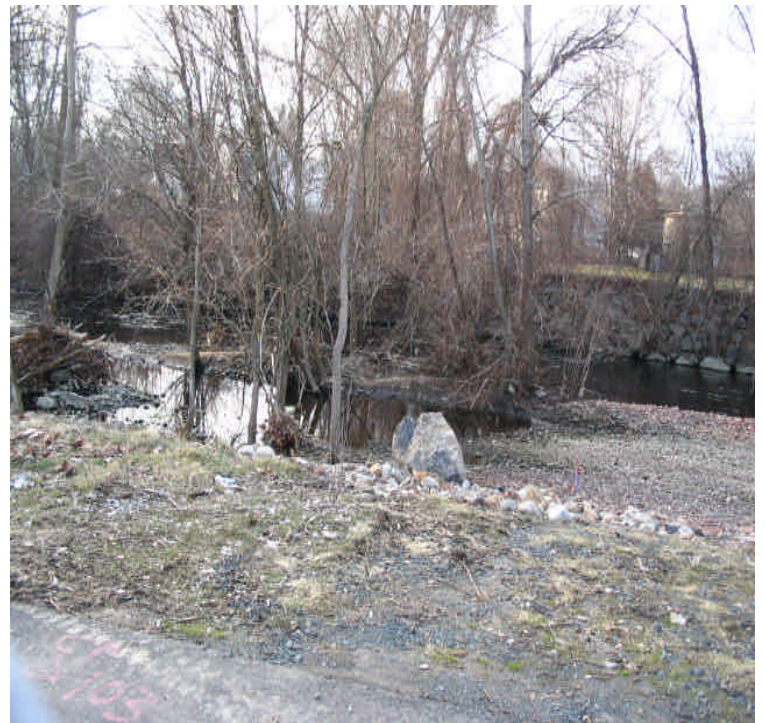
Areas of Inspection	Observation	Recommended Action
Erosion Controls Continued	<ul style="list-style-type: none"> - The overflow channel and natural overflow area were mostly dry at the time of inspection. 2/2/06. - Some sediment was noted collecting in the stone onsite at one of the access gates. This is a result of offsite stormwater 1/4-2/2/06. 	<ul style="list-style-type: none"> - Monitor stormwater flow and drainage patterns when possible. Watch for any erosive flows off site. 1/4-2/2/06.
	<ul style="list-style-type: none"> - A stockpile was in place within silt fence across the Norwalk River as a result of soil testing. This was not immediately part of the substation work. 2/2/06. 	<ul style="list-style-type: none"> - The silt fence was open ended for access but will be closed at the end of each night. 2/2/06.
Inland Wetland and Watercourse encroachment and mitigation	<ul style="list-style-type: none"> - There was no noticeable sediment within the overflow channels. 2/2/06. - Some minor erosion was noted along the top of slope 1/19-2/2/06. 	<ul style="list-style-type: none"> - Sediment deposits naturally along the channel. None at this time. 2/2/06

Both photos show various views of the natural overflow channel. Portions of the channel are dry and portions are partially flooded at the time of inspection. 2/2/06.

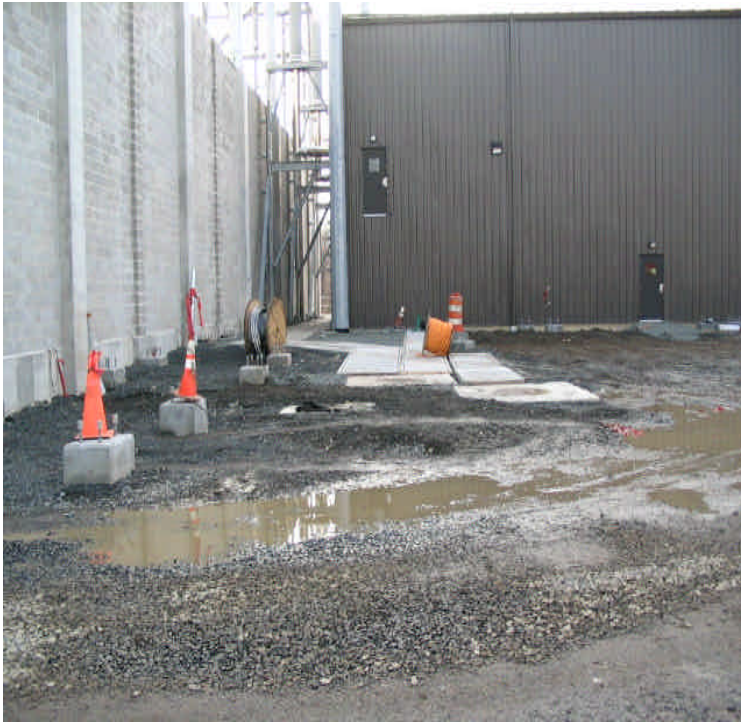
Photo on the left is a view of the work area adjacent to the GIS building. Photo on the right is an overall view of the yard to the north of the GIS building. 2/2/06

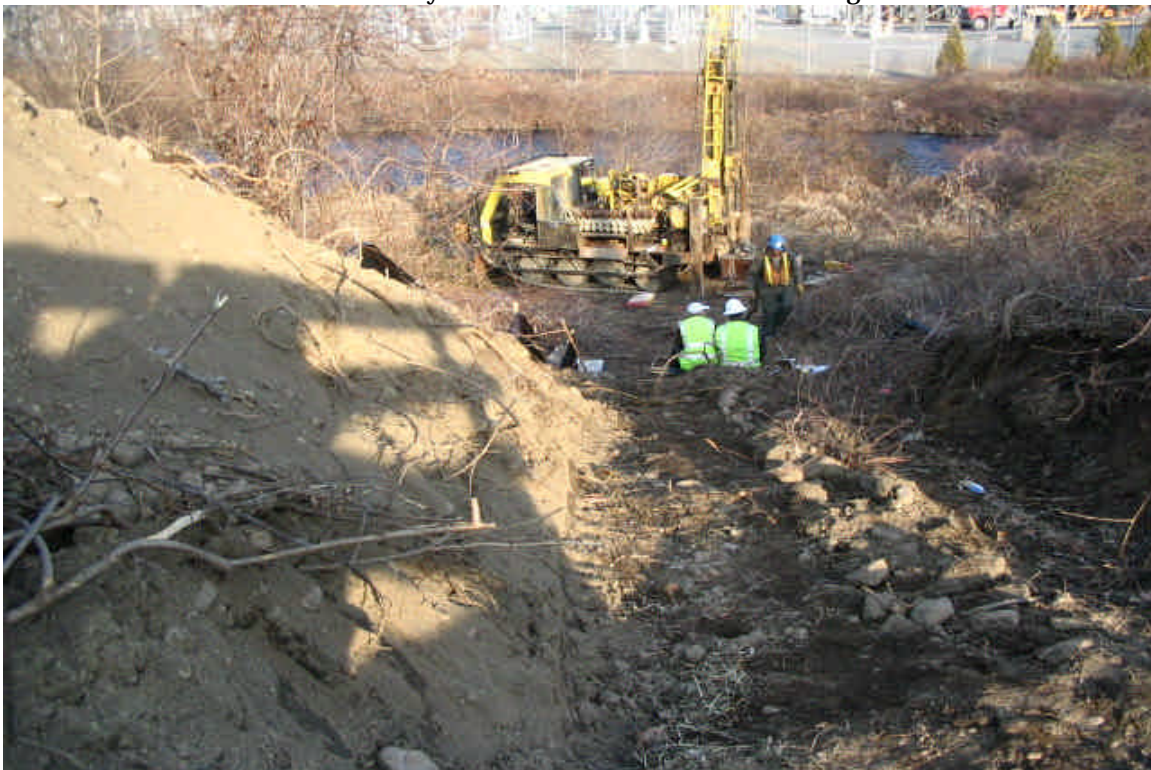
View of the soil test work across the Norwalk River. Work is not immediately associated with the substation but is project related. Silt fence is restored across the work site at the end of each day. 2/2/06
